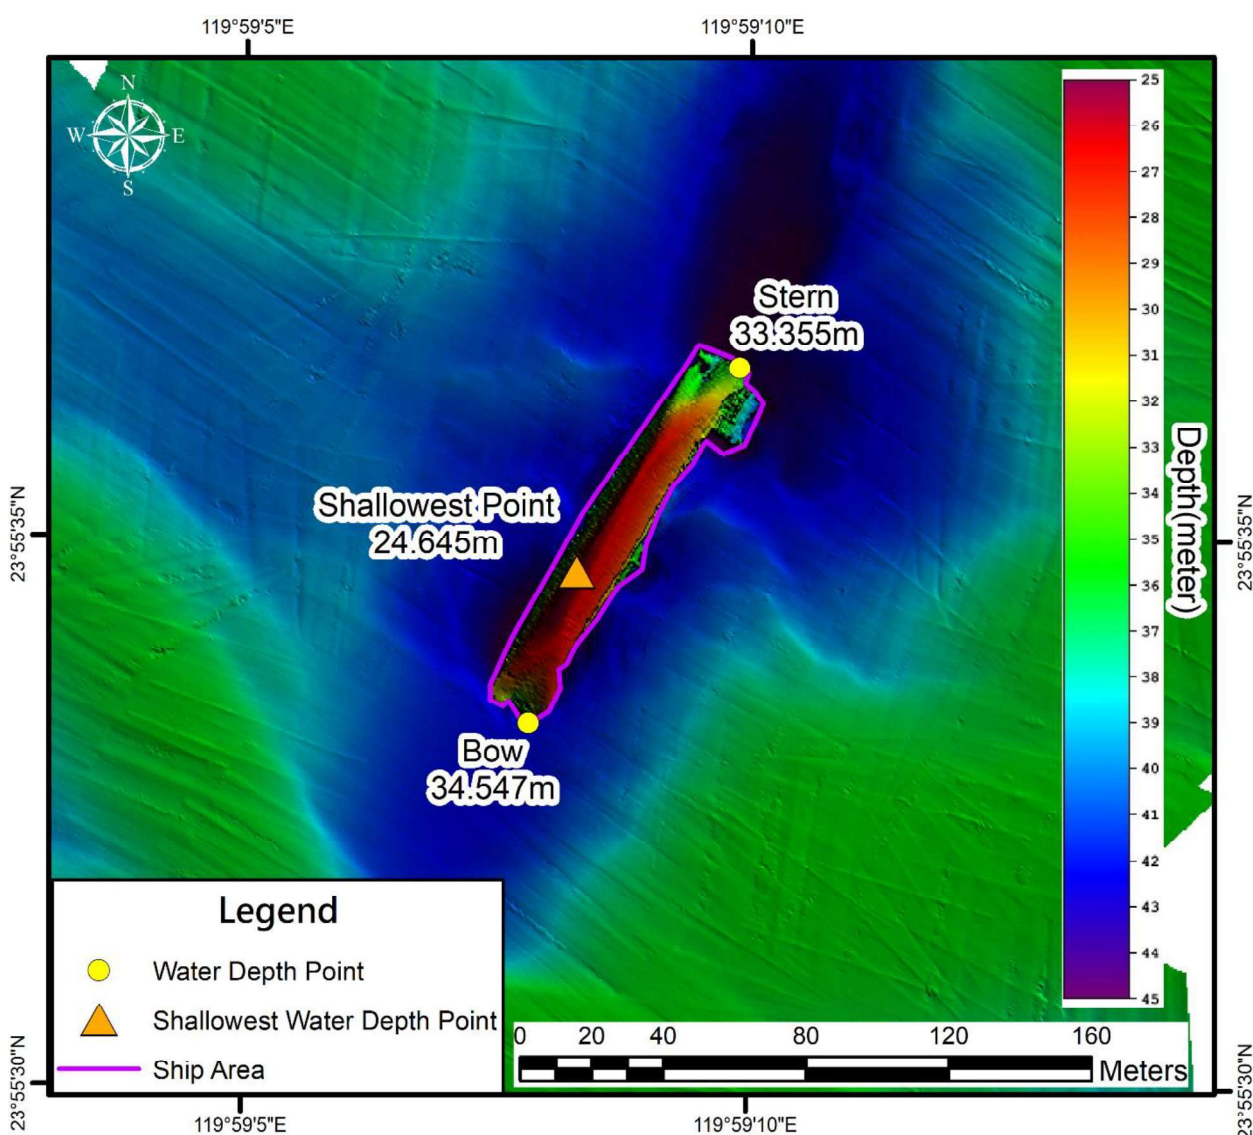
圖 3-2、最淺點水深位置圖

依據多音束測深成果如圖 3-2 所示，船體水深最淺處位於「緯度 23 度 55 分 34.69 秒，經度 119 度 59 分 08.43 秒，深度 24.645 公尺(最低天文潮)」。其他點位資訊如表 3-1 所示。

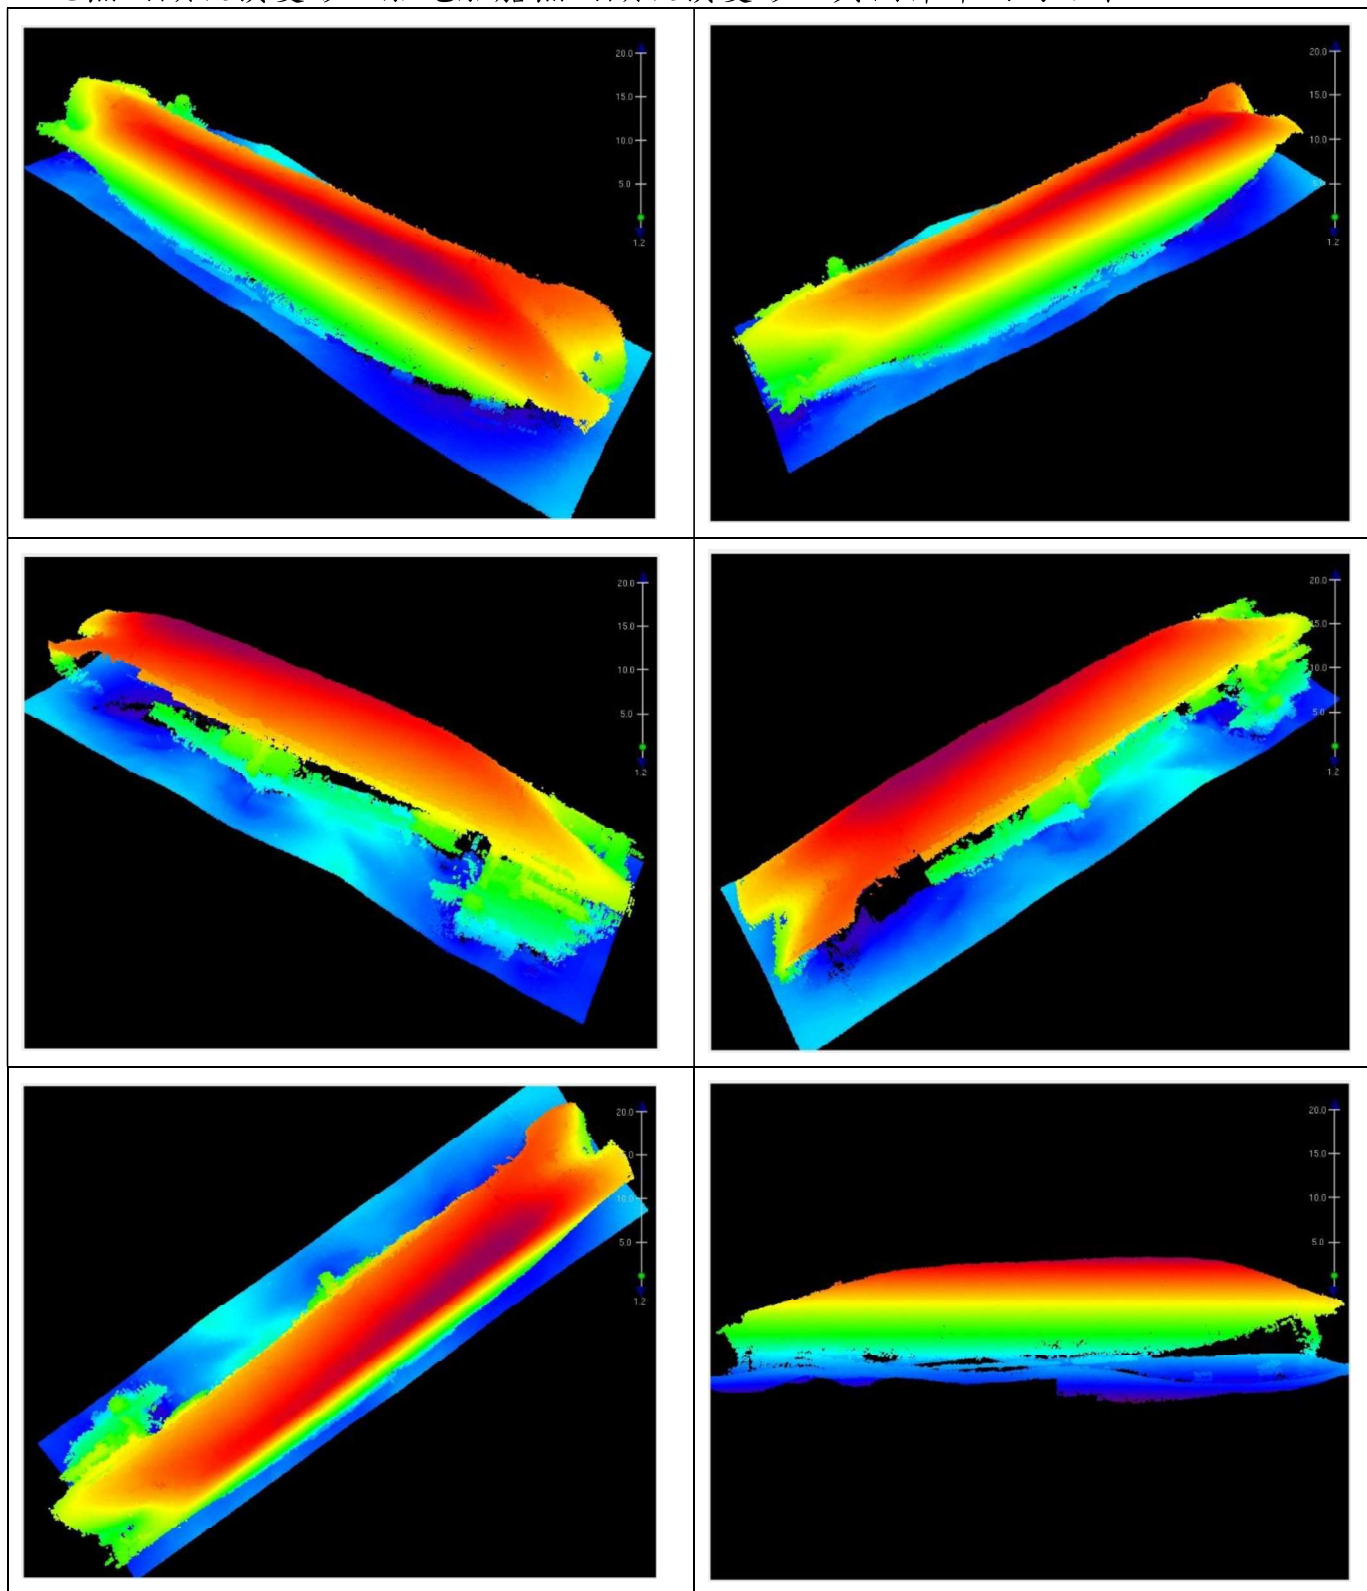
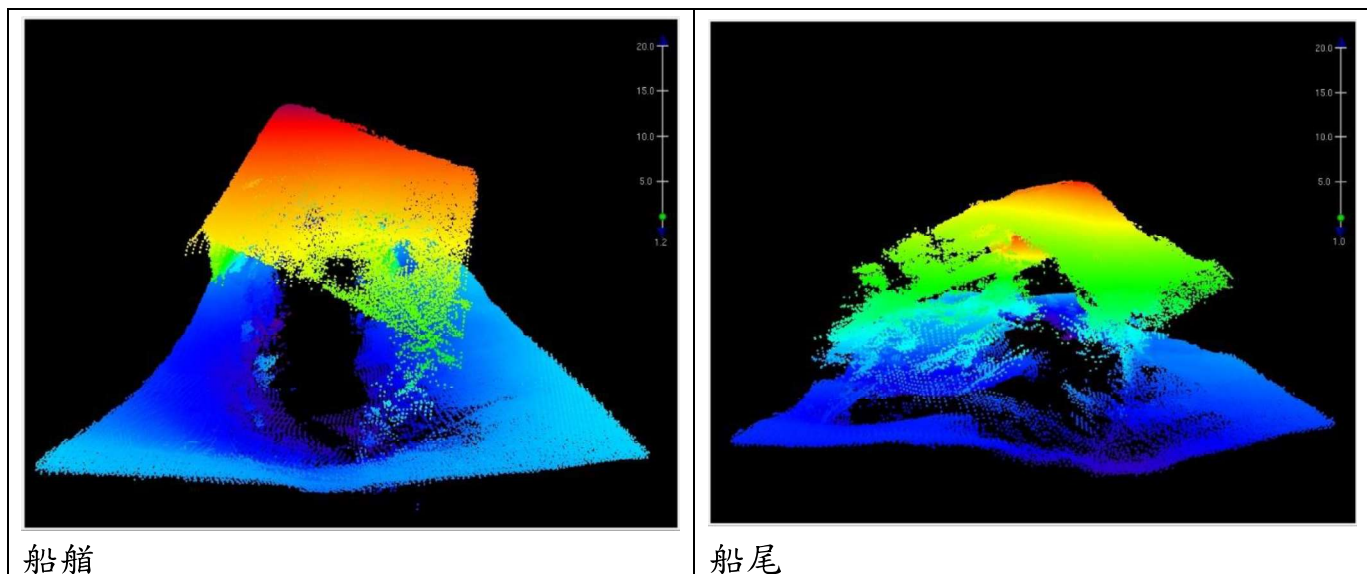
圖 3-3、多音束水深點雲影像

根據多音束水深點雲影像如圖 3-3 所示，可以判斷出船左傾斜橫躺於海床上，船艙處微微向上翹起，概略計算船體左傾約 108.1 度，後傾約 1.5 度。由點雲影像判斷，船體右舷結構完整無明顯破損或變形處，隱約可見主甲板上設

施無明顯破損變形，船尾船艙無明顯破損變形，與側掃聲納的結果一致。

相較行航港局公布之最淺水深約 15.393 公尺，此次測量結果顯示最淺水深約 24.645 公尺，最淺深度明顯增加，結合船體周遭地形的明顯下陷，可能代表船體隨時間有明顯的下沉。探測成果顯示船體向左傾斜超過 108 度，左舷朝下橫臥於海床上，船體整體結構完整並無明顯破損處，可以清楚辨識出船艙與主甲板上設施。船隻整體位置與公布之位置基本一致，並無移動跡象。船體周圍地貌上皆為一般地貌特徵，並無發現其他脫落的船隻殘骸。

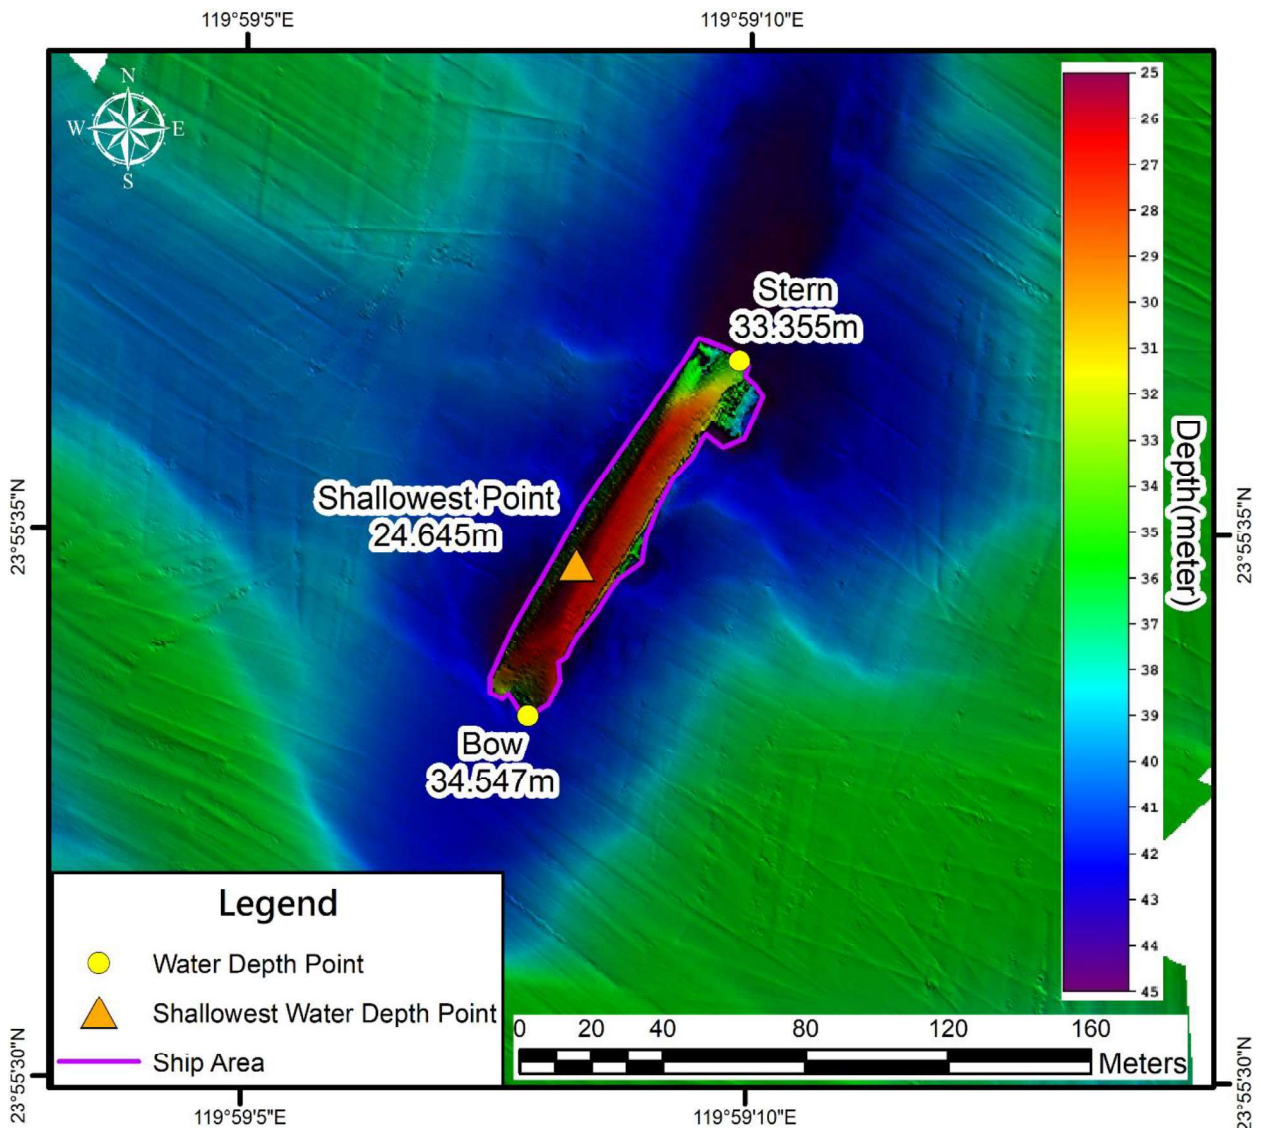
Figure 3-2 、 Shallowest Water Depth Location

According to the results of the multi-beam depth measurement shown in Figure 3-2, the shallowest point of the ship's depth is located at "latitude 23 degrees 55 minutes 34.69 seconds, longitude 119 degrees 59 minutes 08.43 seconds, depth 24.645 meters(LAT)". Other points detail show in Table 3-1.

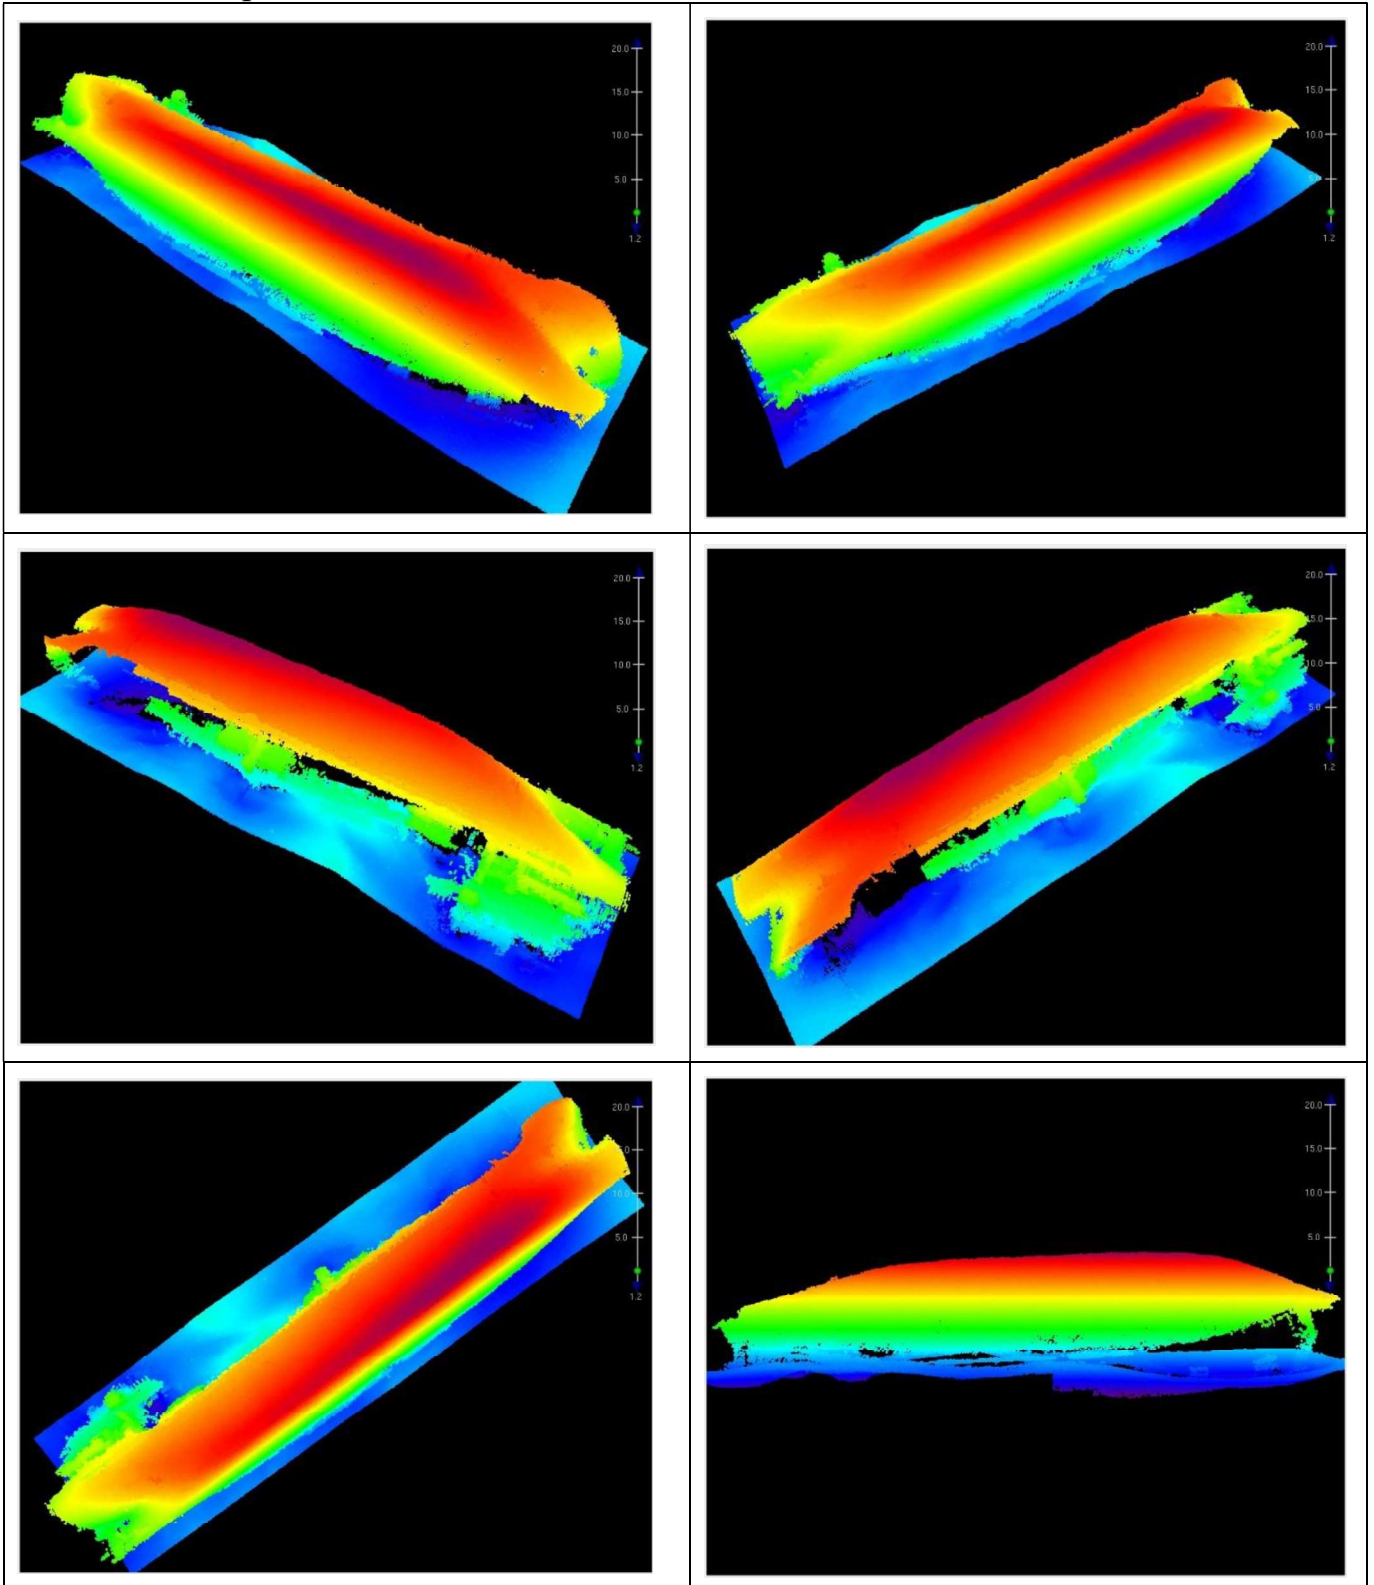
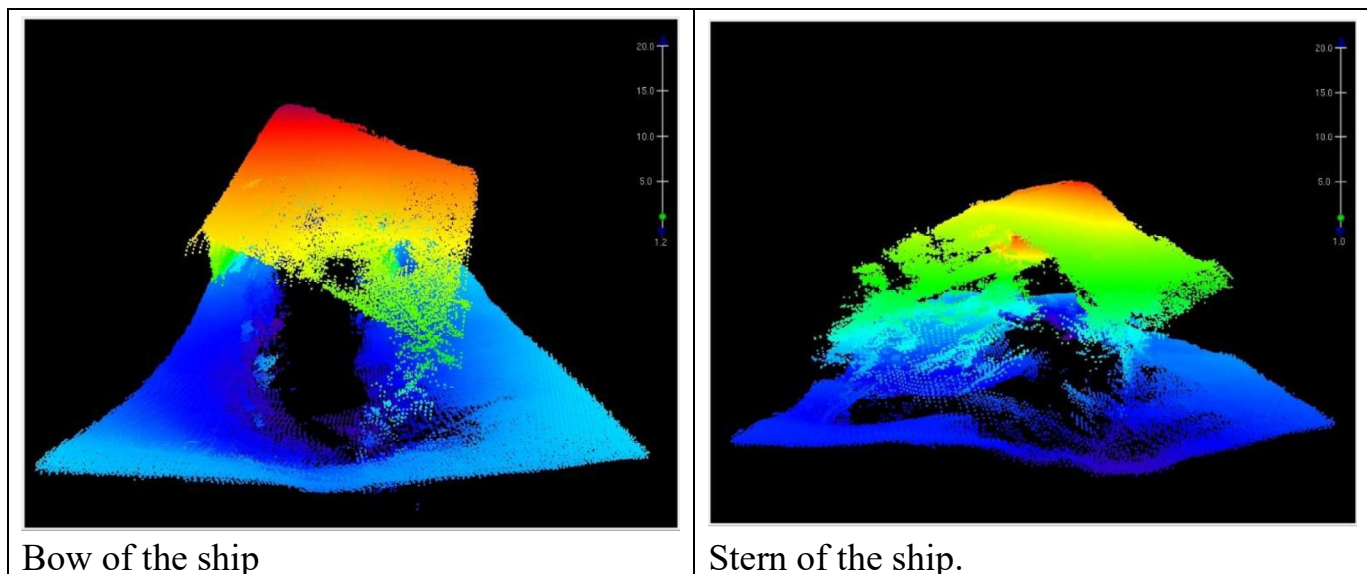
Figure 3-3 、 Multibeam bathymetric point cloud image

According to the multi-beam depth point cloud image shown in Figure 3-3, it can be determined that the ship is tilted to the left and lying on the seabed, with the

bow slightly raised. The approximate calculation shows that the ship is tilted about 108.1 degrees to the left and about 1.5 degrees to the rear. Judging from the point cloud image, the structure on the starboard side of the ship is intact without obvious damage or deformation. The facilities on the main deck are slightly visible without obvious damage or deformation, and there is no obvious damage or deformation in the stern compartment, which is consistent with the results of the side-scan sonar.

Compared to the shallowest depth of approximately 15.393 meters published by the Maritime and Port Bureau, the measurement results of this survey show a shallowest depth of approximately 24.645 meters. The shallowest depth has significantly increased, and combined with the obvious sinking of the surrounding terrain, it may indicate that the ship has significantly sunk over time. The survey results show that the ship is tilted to the left by more than 108 degrees, lying horizontally on the seabed with the port side facing downwards. The overall structure of the ship is intact without any obvious damage, and the facilities on the cabin and main deck can be clearly identified. The position of the ship as a whole is basically consistent with the published position, and there is no sign of movement. The surrounding terrain of the ship is characterized by typical features, and no other wreckage of ships has been found.
